PIC18(L)F24/25K40

PIC18(L)F24/25K40 Family Silicon Errata and Data Sheet Clarification

The PIC18(L)F24/25K40 devices that you have received conform functionally to the current device data sheet (DS40001843D), except for the anomalies described in this document.

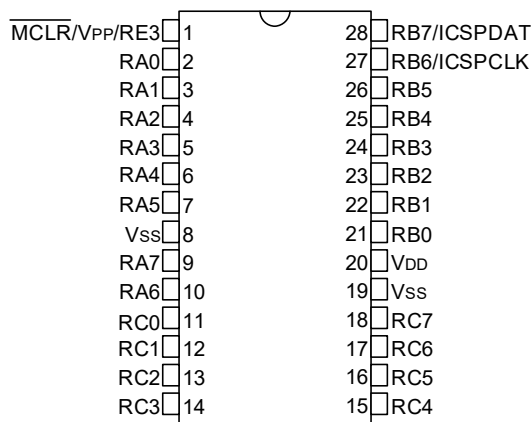
Figure 1. 28-pin SPDIP, SSOP, SOIC

The correct marking for pin 26 on the 28-pin SPDIP/SSOP/SOIC package is **RB5**.

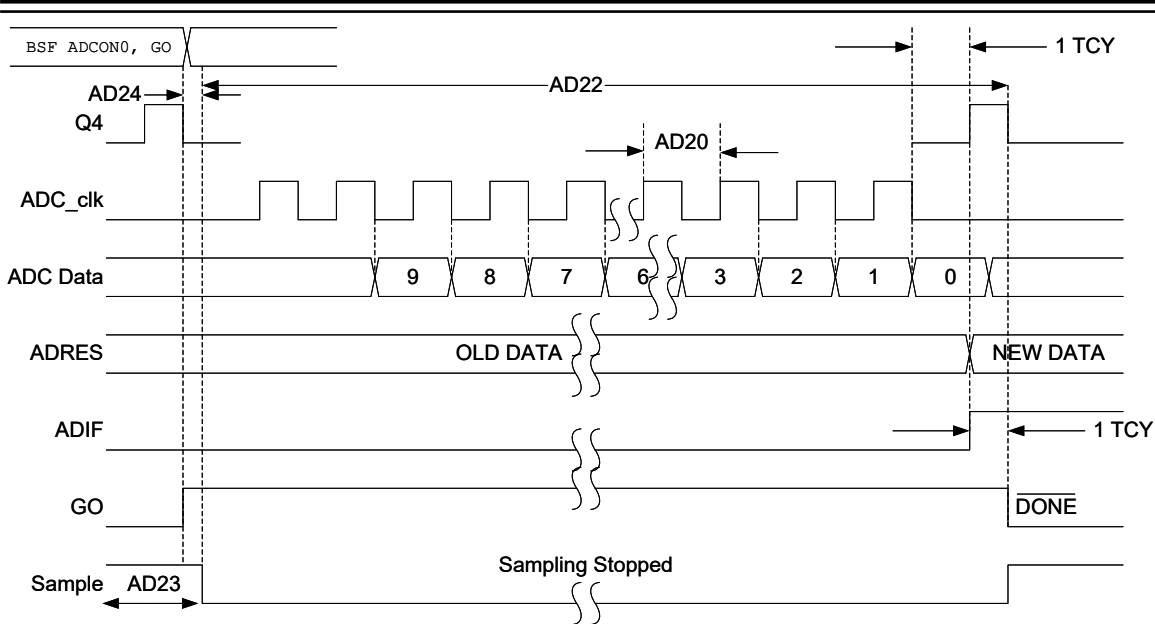
Figure 38-10: ADC Conversion Timing (ADC Clock F_{OSC}-Based)

Refer to the images below for corrections of Figure 38-10 and Figure 38-11. Previously, the parameter numbers were incorrect.
