# PIC18(L)F26/45/46K40

## PIC18(L)F26/45/46K40 Family Silicon Errata and Data Sheet Clarification

The PIC18(L)F26/45/46K40 devices that you have received conform functionally to the current device data sheet (DS40001816F), except for the anomalies described in this document.

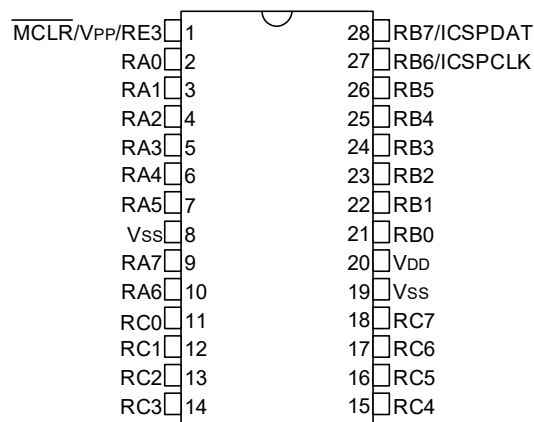
Figure 1. 28-pin SPDIP, SSOP, SOIC

The correct marking for pin 26 on the 28-pin SPDIP/SSOP/SOIC package is **RB5**.

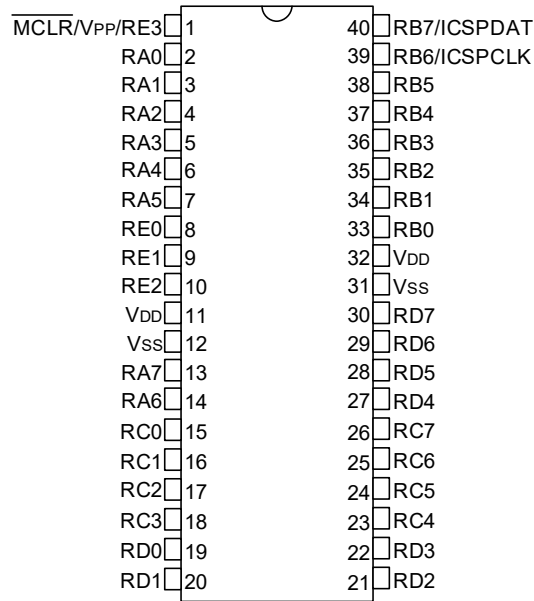
Figure 3. 40-pin PDIP

The correct marking for pin 38 on the 40-pin SPDIP package is **RB5**.

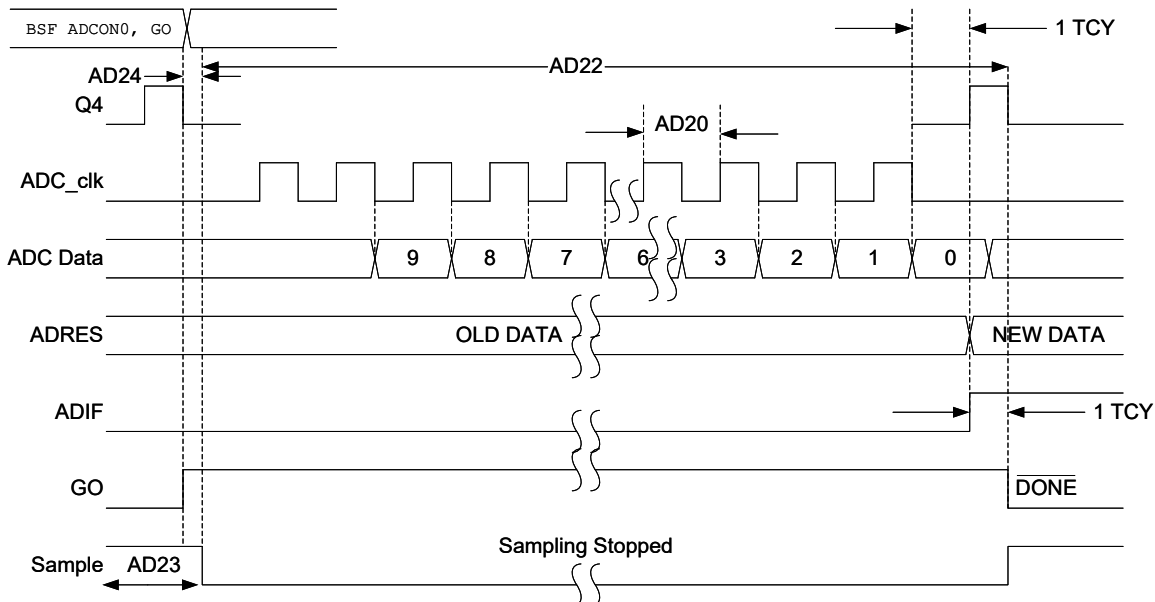
**Figure 38-10: ADC Conversion Timing (ADC Clock  $F_{OSC}$ -Based)**

Refer to the images below for corrections of Figure 38-10 and Figure 38-11. Previously, the parameter numbers were incorrect.
