PIC32MK General Purpose and Motor Control (GP/MC) Silicon Errata and Data Sheet Clarification

The PIC32MK General Purpose and Motor Control (GP/MC) family of devices that you have received conform functionally to the current Device Data Sheet (DS60001402G), except for the anomalies described in this document.

The silicon issues discussed in the following pages are for silicon revisions with the Device and Revision IDs listed in [Table 1](#). The silicon issues are summarized in [Table 2](#).

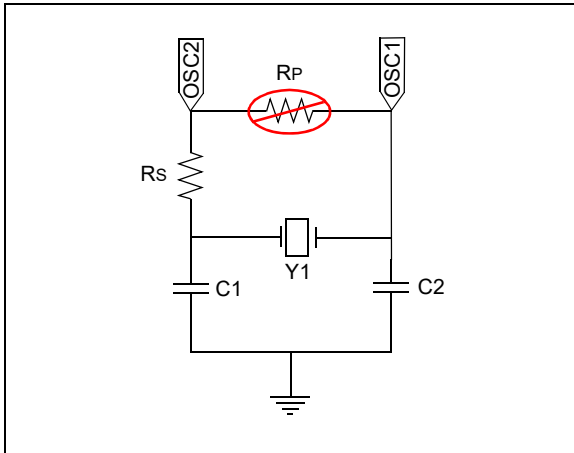
FIGURE 1: POSC CRYSTAL CIRCUIT

The POSC supports only specific crystal operation, as provided in [Table 1](#).

The Primary Oscillator (POSC) has been characterized to operate at 8 MHz and 12 MHz when the circuit shown in [Figure 1](#) is implemented and the operating conditions provided in [Table 1](#) are met.

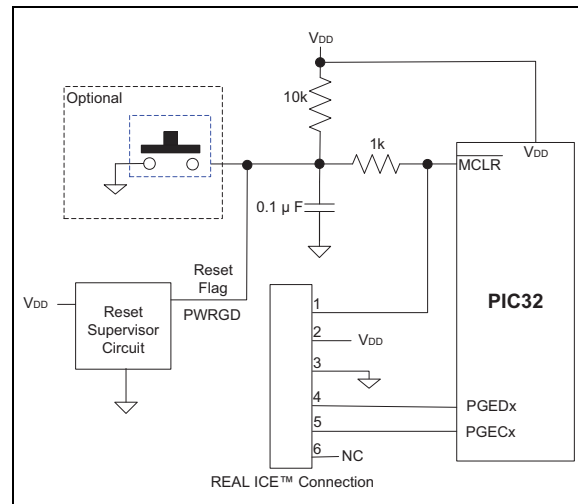
FIGURE 2: RESET SUPERVISOR CIRCUIT

On a BOR event, $V_{POR} < V_{DD} < V_{BOR}$, a Reset is not generated when the BOR threshold is reached. System clocks will stop with all I/O pins functions frozen in their present state until either V_{DD} falls to V_{POR} or V_{DD} returns to above V_{BOR} . The user must assess if this V_{DD} brown-out condition and the resulting frozen I/O pin state has an adverse effect on their application (UART, PWM, I/O, OC, etc.).

If the application can sustain frozen I/O states for ~2.1 ms (UART, CAN, I/O, etc.), the application must enable the Deep Sleep Watchdog Timer and Clock Fail Monitor, based on the details provided in Table 3 and Table 4. If implemented correctly, after ~2.1 ms, a valid internal reset state is entered and the I/O pins are set to the device default Reset state.
