## PIC32MZ Graphics (DA) Family Silicon Errata and Data Sheet Clarification

The PIC32MZ Graphics (DA) family of devices that you have received conform functionally to the current Device Data Sheet (DS60001361H), except for the anomalies described in this document.

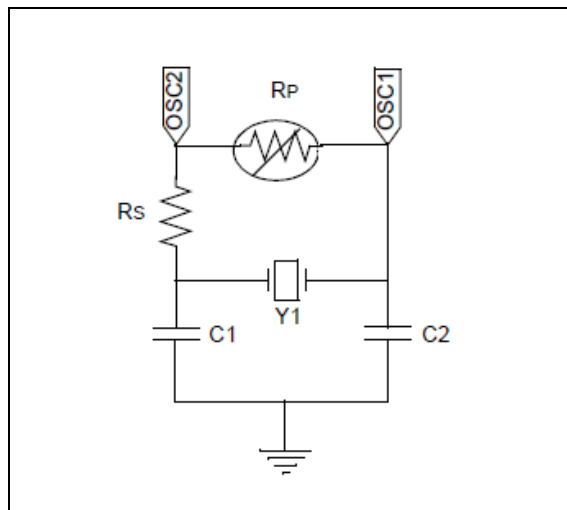
FIGURE 1: Posc CRYSTAL CIRCUIT

The POSC has been tested in a normal power-up sequence and supports specific crystal operation.

The Primary Oscillator (Posc) has been characterized to operate at 8 MHz and 12 MHz when the circuit shown in Figure 1 is implemented, and the operating conditions listed in Table 3 are met.

Crystal Frequency (See Note 1)	Series Resistor Rs	Posc Gain Setting POSCGAIN<1:0> (DEVCFG0<20:19>)	Posc Boost Setting POSCBOOST (DEVCFG0<21>)
8 MHz	2 kΩ	'0b00 (GAIN_0)	'0b1
12 MHz	1 kΩ	'0b00 (GAIN_0)	'0b1

**Note 1:** Using any other crystal frequency will require special component selection and characterization.

**2:** A parallel register (Rp) should not be used to increase the gain of the Posc.

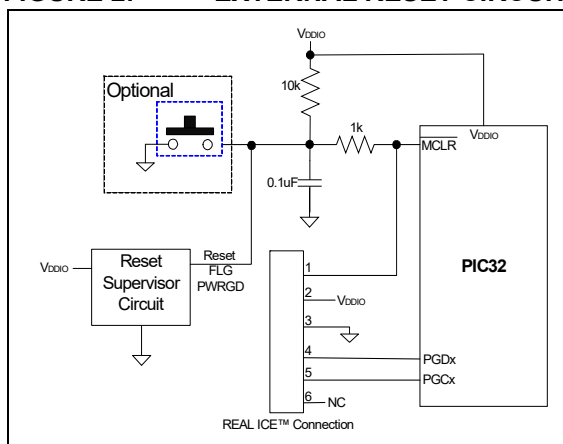
FIGURE 2: EXTERNAL RESET CIRCUIT

A system Reset is not generated on a BOR event ( $V_{PORIO} < V_{DDIO} < V_{BORIO}$ ). This will stop system clocks with all the I/O pin functions frozen in the present state until either  $V_{DDIO}$  falls to  $V_{PORIO}$  or  $V_{DDIO} > V_{BORIO}$ .

Reset device using a  $\overline{MCLR}$  pin through an external reset supervisor/monitor is shown in Figure 2. Set the SMCLR (DEVCFG2<15>) configuration bit to '0', which makes the  $\overline{MCLR}$  to act as a POR Reset instead of a normal system reset.

- Minimum Reset trip voltage of the external supervisor should be  $V_{BORIO}(\text{Max}) + 0.5V$ .
- The external reset supervisor/LDO output going to  $\overline{MCLR}$  should have an open drain output to not interfere with the MPLAB programming/debug tools.

When this work around is implemented, the minimum  $V_{DDIO}$  operating voltage of the application needs to be above the reset supervisor maximum trip voltage + 0.2V, where 0.2V compensates for variation in the external reset supervisor voltage.
