STM32F030x4/x6/x8/xC device errata

Applicability

This document applies to the part numbers of STM32F030x4/x6/x8/xC devices and the device variants as stated in this page. It gives a summary and a description of the device errata, with respect to the device datasheet and reference manual RM0360. Deviation of the real device behavior from the intended device behavior is considered to be a device limitation. Deviation of the description in the reference manual or the datasheet from the intended device behavior is considered to be a documentation erratum. The term “*errata*” applies both to limitations and documentation errata.

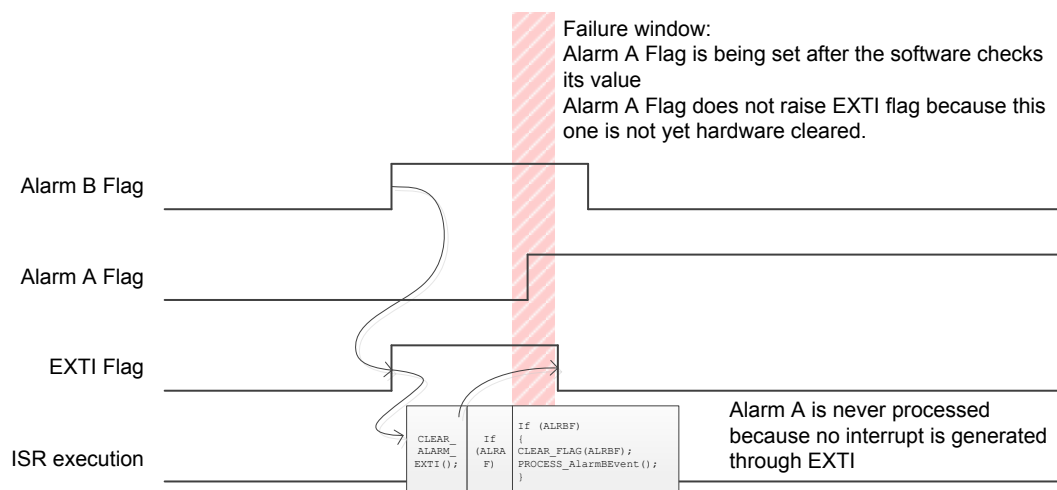
Figure 1. Masked RTC interrupt

The following code example and figure illustrate the failure mechanism: The Alarm A event is lost (fails to generate interrupt) as it occurs in the failure window, that is, after checking the Alarm A event flag but before the effective clear of the EXTI interrupt flag by hardware. The effective clear of the EXTI interrupt flag is delayed with respect to the software instruction to clear it.
