STM32MP151x/3x/7x device errata

Applicability

This document applies to the part numbers of STM32MP151x/3x/7x devices and the device variants as stated in this page.

It gives a summary and a description of the device errata, with respect to the device datasheet and reference manual RM0441 for STM32MP151x, RM0442 for STM32MP153x, and RM0436 for STM32MP157x.

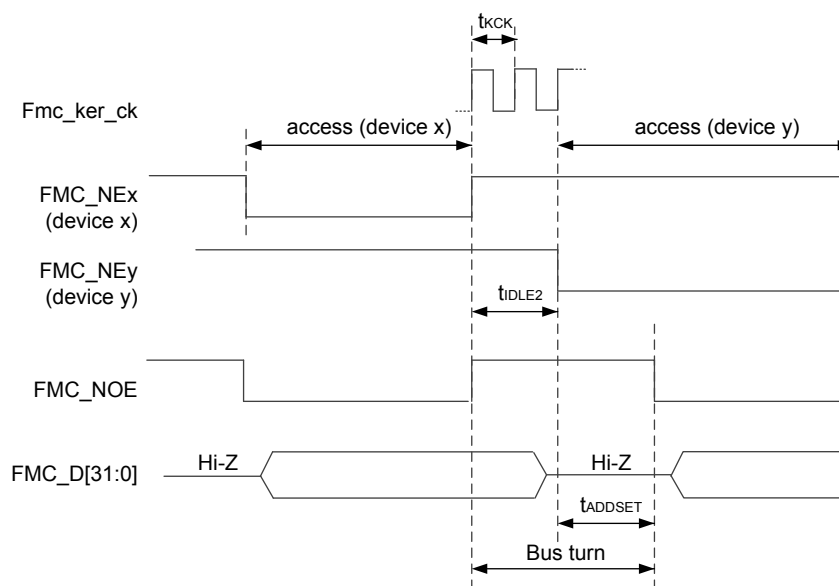
Figure 1. Bus turn timing recovery - asynchronous accesses to NOR/PSRAM devices (case 1)

1. Two consecutive accesses to non-multiplexed NOR/PSRAM devices:
Program t_{ADSET} (NOR/PSRAM address setup phase) as needed (see [Figure 1](#)).
2. Access to a non-multiplexed NOR/PSRAM followed by an access either to a NOR/PSRAM device with multiplexed A/DQ signals or to a synchronous device:
Decrease the FMC kernel clock frequency in order to meet the timing constraints (see [Figure 2](#)).
3. Access to a non-multiplexed NOR/PSRAM followed by an access to a NAND Flash memory device
Program t_{MEMSET} (NOR/PSRAM address setup phase) as needed (see [Figure 3](#)).

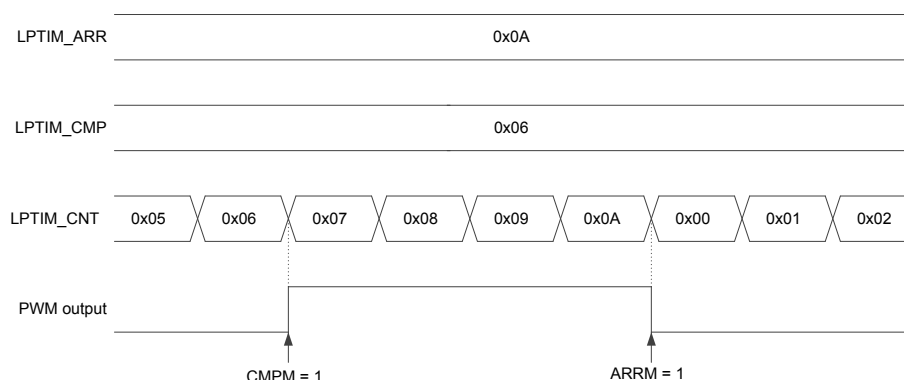
Figure 4. Example of PWM output mode

The following waveform gives the example of PWM output mode and the effect of the delay:

Set the compare value to the desired value minus 1. For instance in order to generate a compare match when LPTM_CNT = 0x08, set the compare value to 0x07.

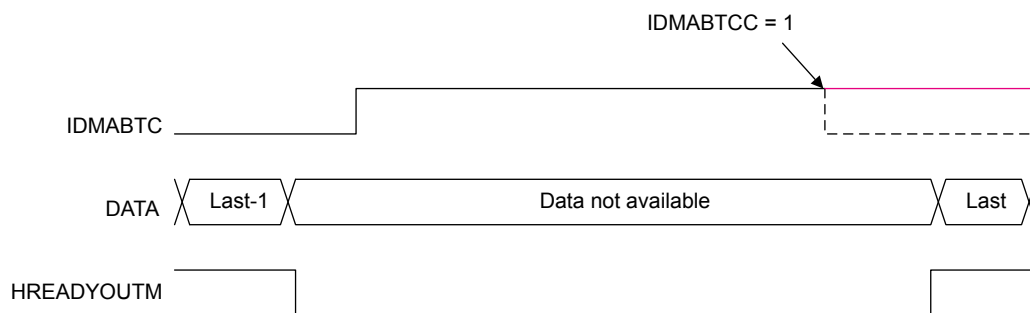
Figure 5. SDMMC AHB transfer vs IDMABTC flag status

If the internal/external memory is not ready to transmit/receive the last word before the IDMABTCC is set, the IDMABTC flag is not cleared whereas it should be (see Figure 5). As a result, the software may consider it several times.
